REPORT DOCUMENTATION PAGE		BEFORE COMPLETING FORM LEVEL	
1. REPORT NUMBER	2. GOVT ACCESSION NO.	3. PARTICIPANT'S STATION NUMBER	
4. TITLE (and Subtitle) Phase I Inspection Report Newtown-Hoffman Creek Watershed Site 3A Chemung River Basin, Chemung County, New York Inventory No. N.Y. 617		5. TYPE OF REPORT & PERIOD COVERED Phase I Inspection Report National Dam Safety Program

PHASE I REPORT
NATIONAL DAM SAFETY PROGRAM

Name of Dam Newtown-Hoffman Site 3a Dam NY617

PHASE I INSPECTION REPORT
NATIONAL DAM SAFETY PROGRAM
NAME OF DAM - NEWTOWN-HOFFMAN ID# - NY617

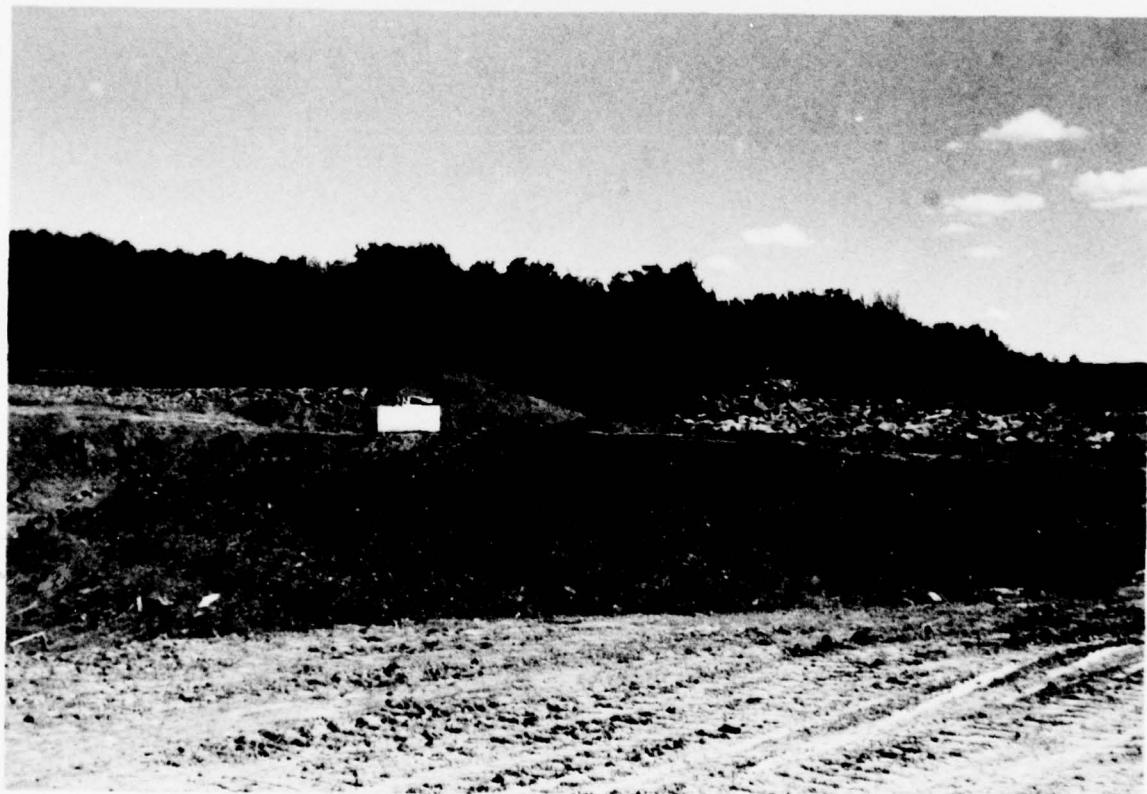
1. View across front of dam. Notice center portion of dam cut to install new principal spillway intake and discharge pipe. Normal pool over flow intake elevation is at top of concrete structure.

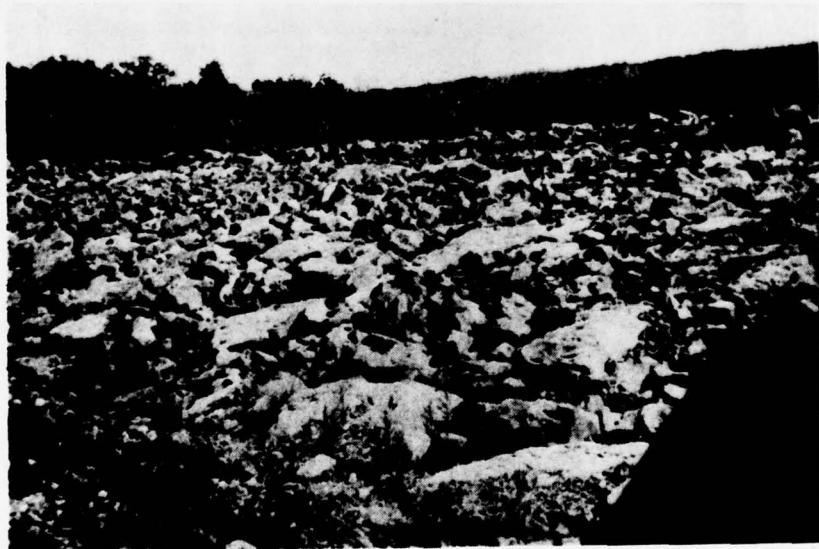
4. Detail of riprap on face of dam.

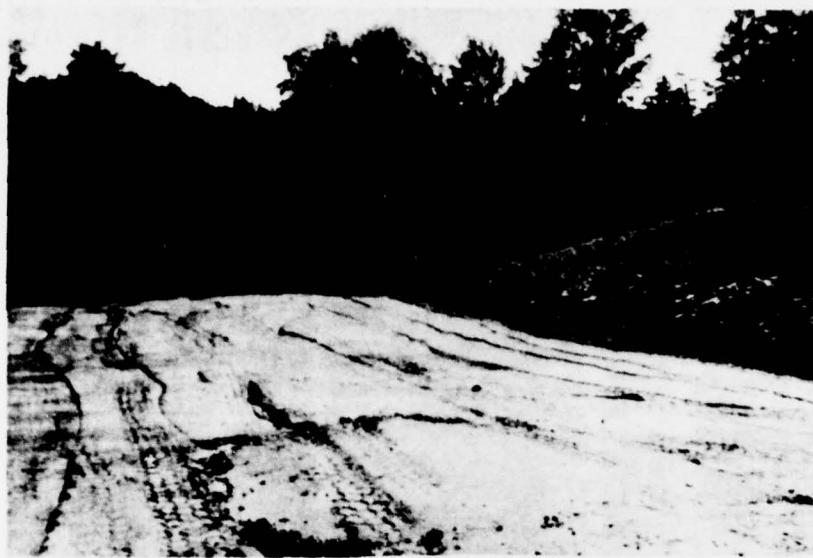
9. South view of compacted earth in cut section over in-place seepage collars and principal spillway pipe.

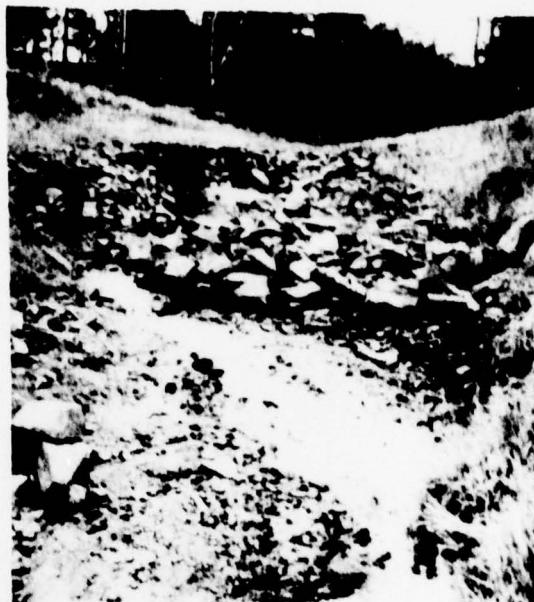
Left: Critical area reseeding will be helped by applying mulch and installing net to hold mulch in place.

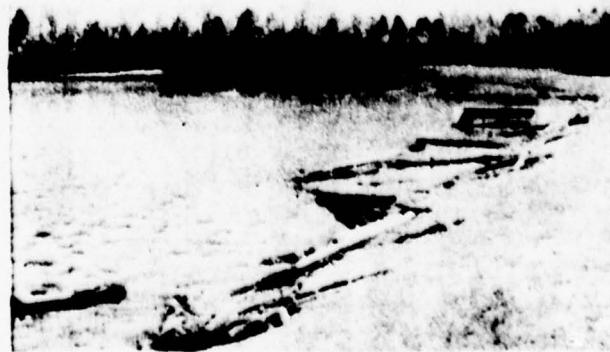
Left: Floating trash can block riser and emergency spillways. Remove immediately. Unexpected storm can severely damage structure.
